**AQUILA REMOTELY PILOTED VEHICLE SYSTEM TECHNOLOGY
DEMONSTRATOR (RPV-STD) PROGRAM
Volume III - Field Test Program**

John A. Nicoletti
LOCKHEED MISSILES & SPACE COMPANY, INC.
Sunnyvale, Calif. 94086

Final Report for Period December 1974 - December 1977

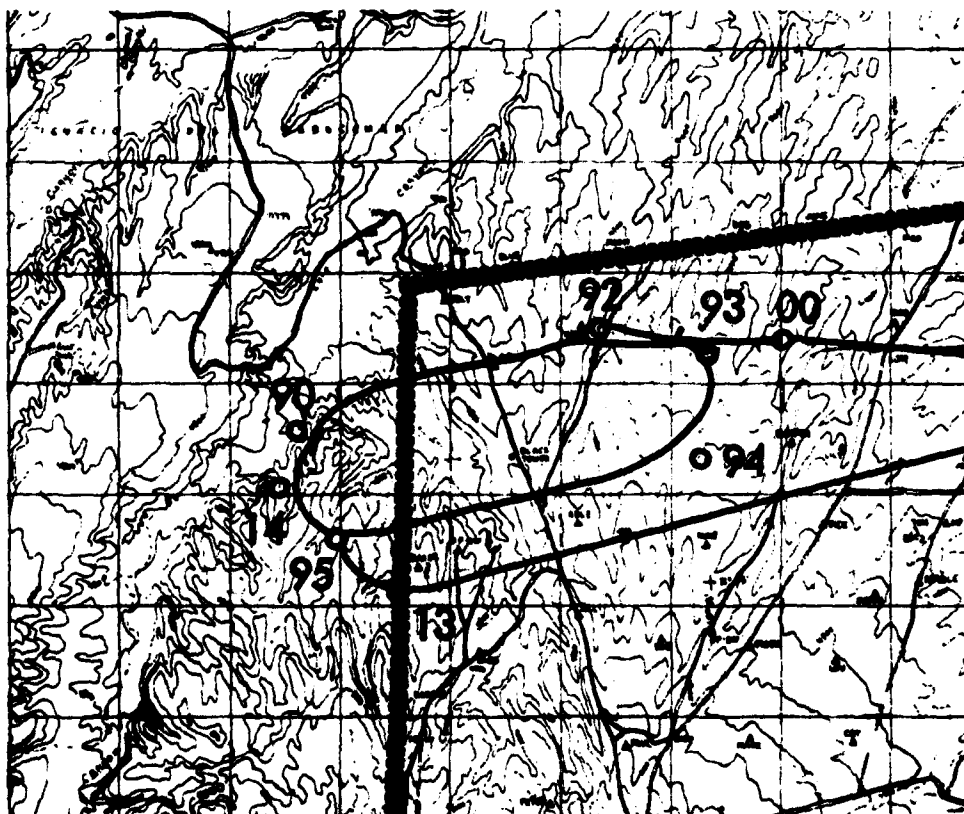
Figure 14. Flight Path, Flight 28 (West Range)

Figure 18. Flight Path, Flight 28 (East Range)

- Demonstrate system operation to a range of 20 km
 - Demonstrate climb performance to 2,740 m (9,080 ft), altitude MSL.
- The flight path is depicted in Figures 14 and 15.

The highest altitude reached was 2,684 m (8,800 ft) MSL, between waypoints 06 and 07. At this point, the RPV was climbing at the rate of 90 m/min (300 fpm). Then the RPV was put in a sharp dive toward waypoint 07. The maximum indicated airspeed during this dive was 188 km/h (101 knots), during the initial pitch-down maneuver. Engine rpm at this time was 9,000.
